# **Mighty Tracker - Assembly Trial -**

Maria Queiroga Bazetto, Sven Wonsak

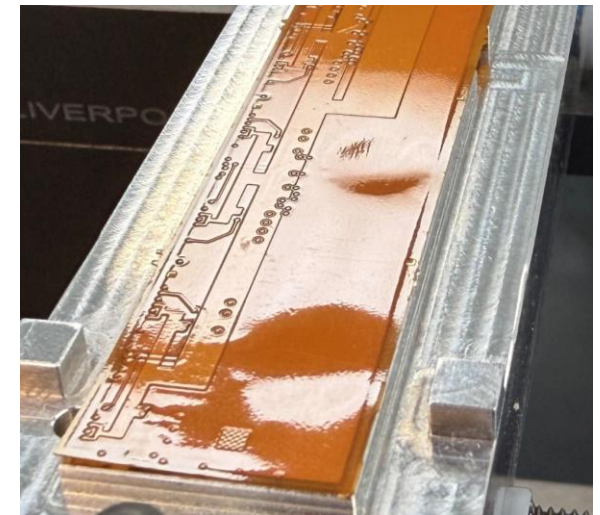
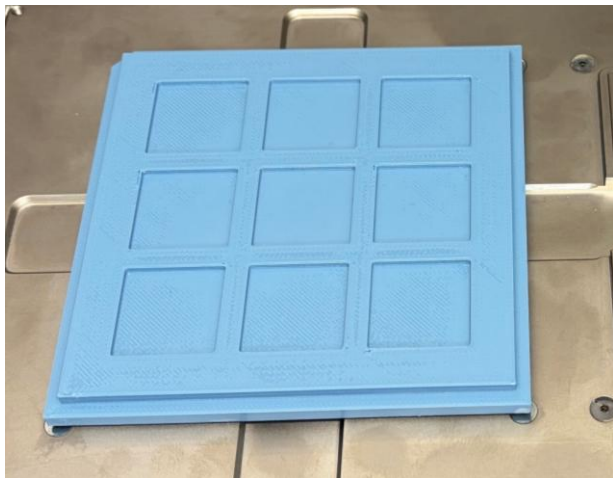
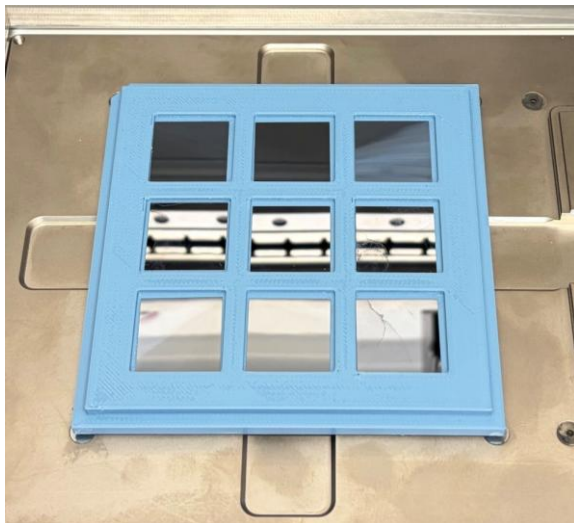
- 3D printed waffle pack for chip alignment/pick-up
  - Backside of filament-printed waffle pack not smooth enough for machine vacuum to hold it down
- To note: removing these dummies from the dicing tape is challenging
  - Likely UV release tape (no equipment for that)
  - Dicing quite deep into tape, it easily tears in the dicing streams

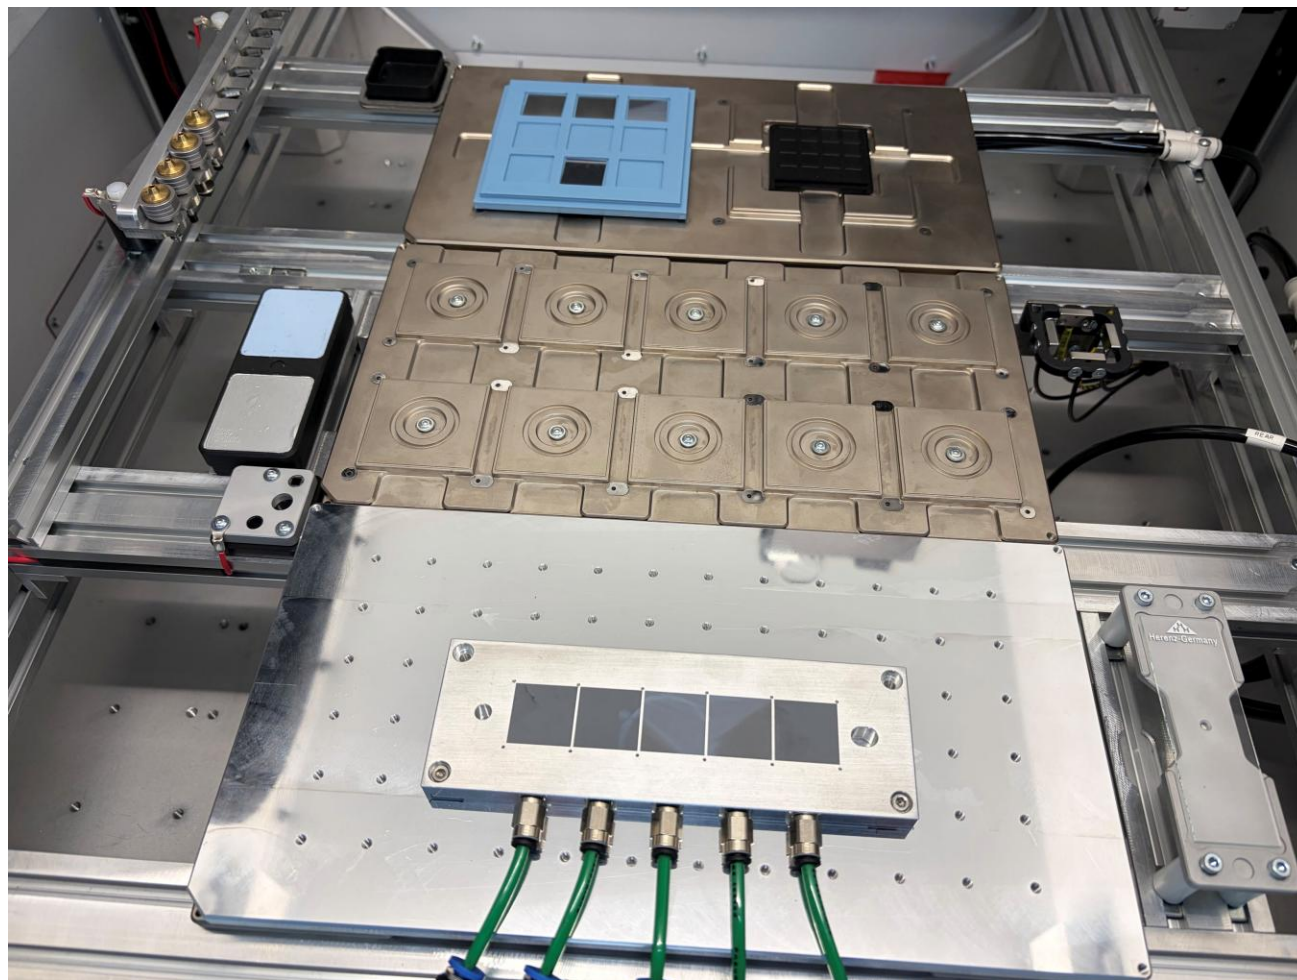
Machine skipped one chip on waffle pack because it could not find the edges (dirty from propanol, cleaning helped)

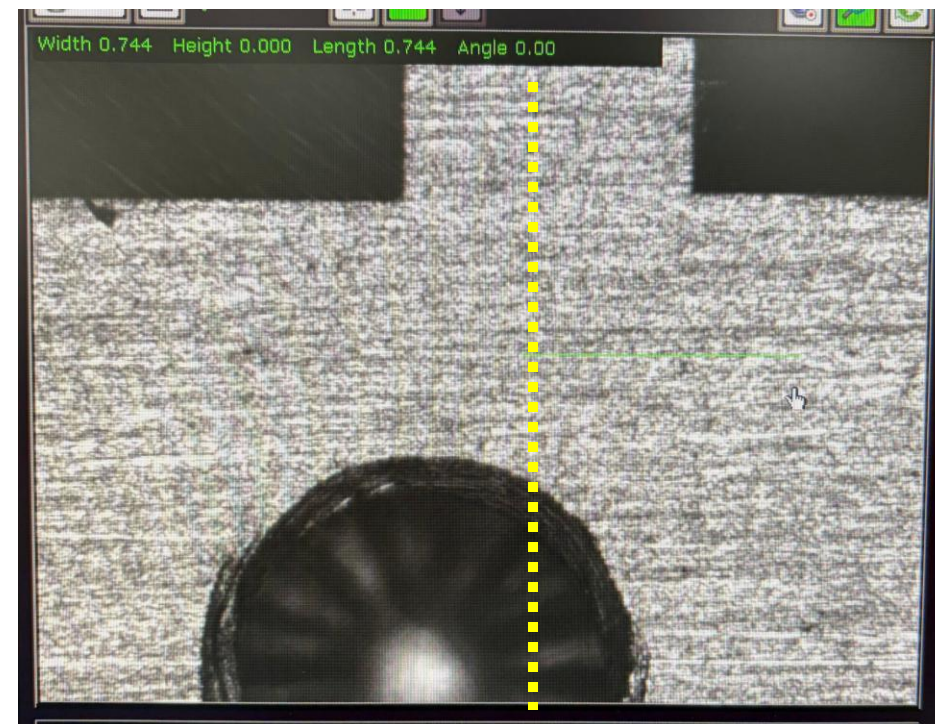
Alignment slightly wrong  
- Hole should be in centre of gap

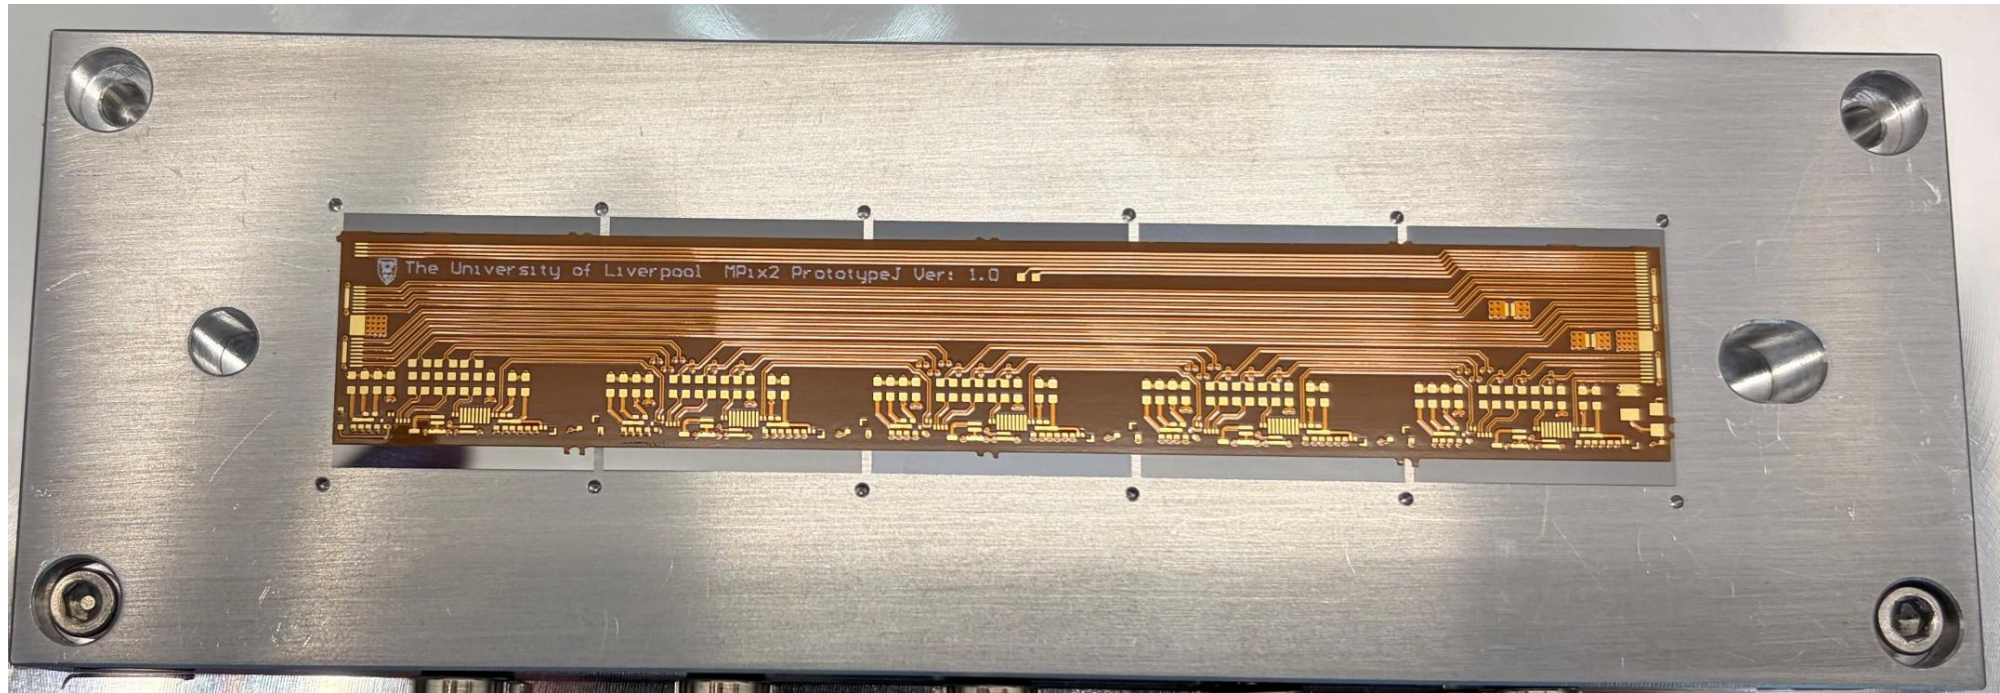
Shift of chips to right side visible

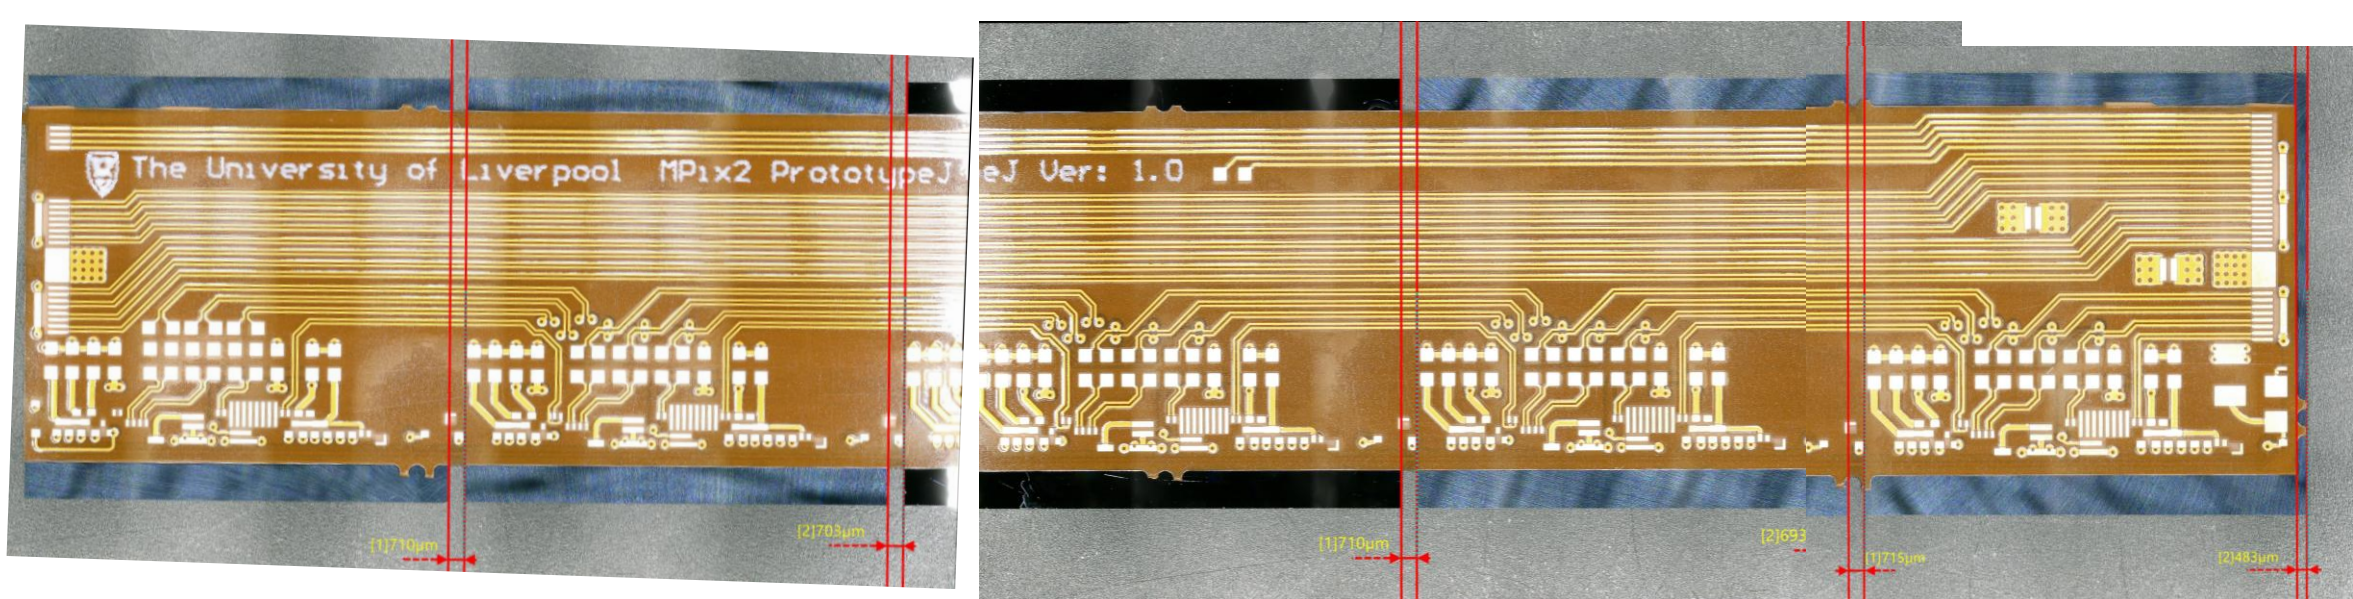
Gaps left to right: 710um, 703um, 710um, 715um

- In general very consistent

Left side: no gap between flex and chip; right side a gap of 483um -> misalignment

Measurement accuracy not ideal:

- Hard to distinguish chip from background (higher magnification and white background should help)
- Not all chips parallel

Expected gap from tool  
drawings: 1.325

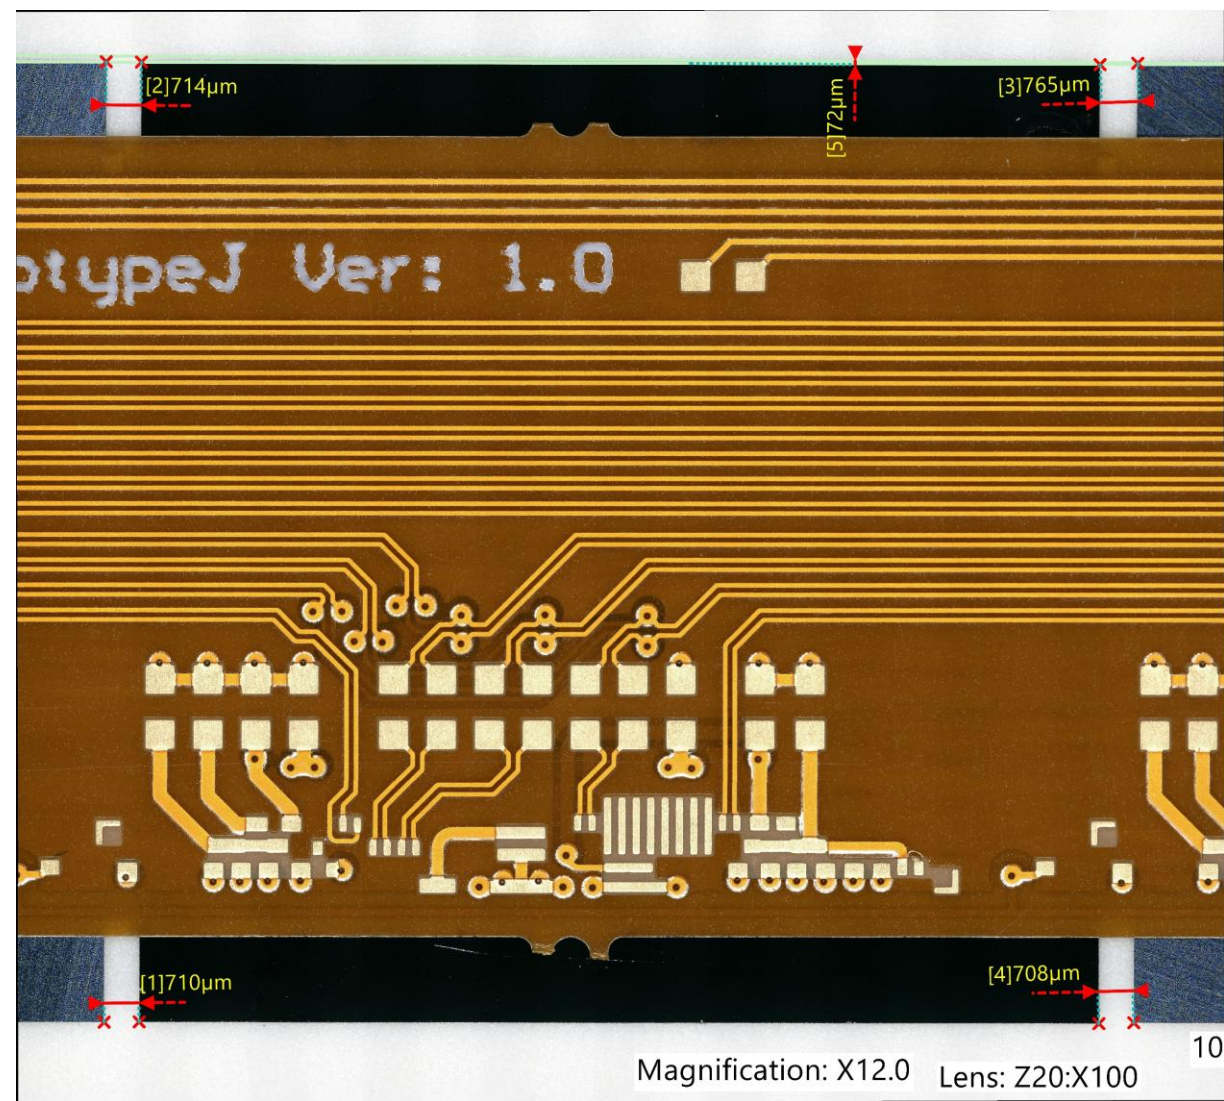
Top and bottom distance on right side different -> rotation

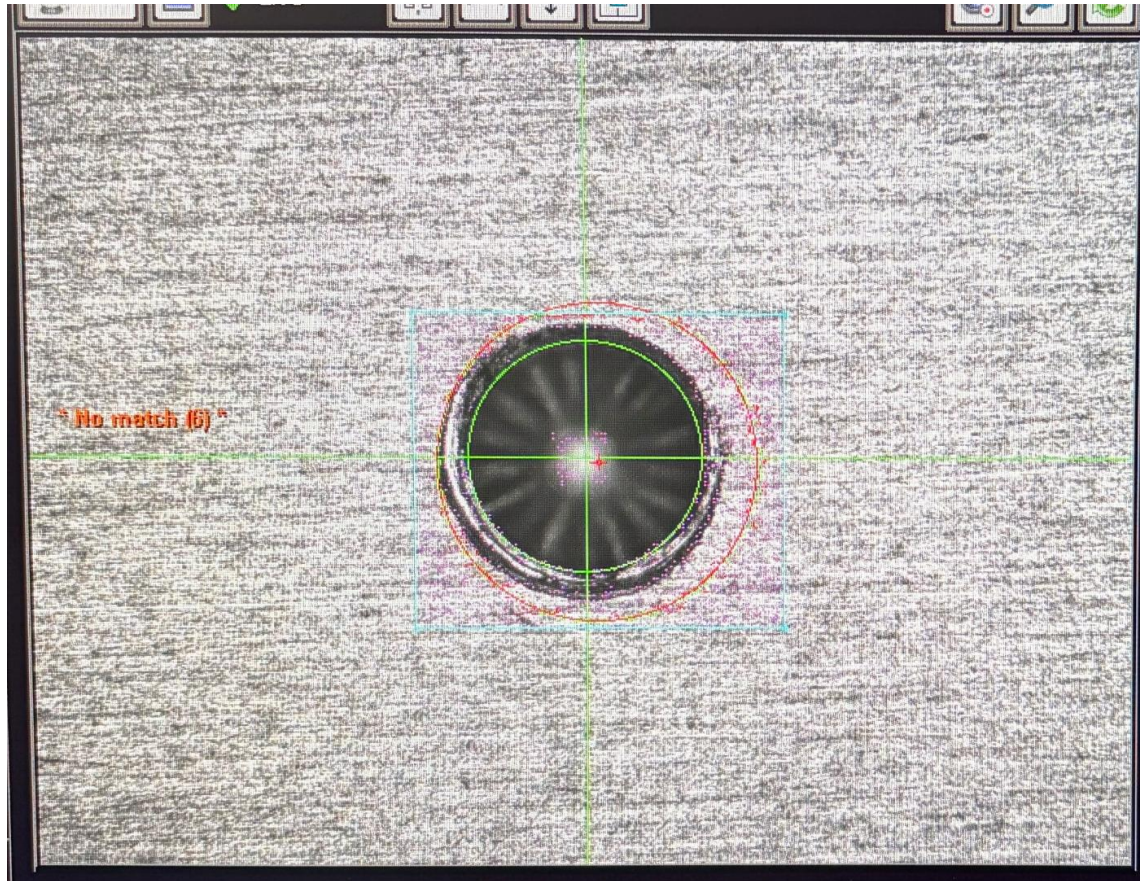
- Machined holes not of sufficient quality for automated feature finding with pick-and-place machine
  - Workshop thinks it could be done with setting up machine correct
- Otherwise, needs to be changed
  - Use grooves/+ fiducial instead?
  - Brass bushings?

- Perform metrology of jig to check that alignment hole locations are correct
- Ask nicely in workshop if they could re-machine the holes in one of the jigs
