Characterisation Of Substrate Resistivity For A Backside Biased HV-CMOS Pixel Test Structure By eTCT

Benjamin Wade

14/06/2022

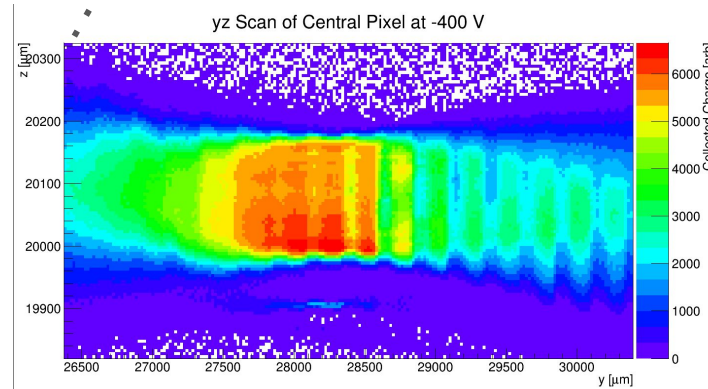
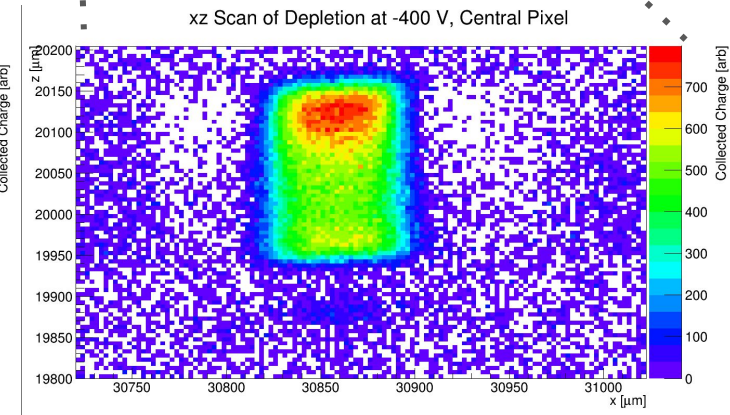
Spacial Scan Types

- Chip moved in 3 dimensions
- Focus the laser on central diode in 3 x 3 test structure
- Find ideal x & y coordinates to measure depletion depth of central pixel

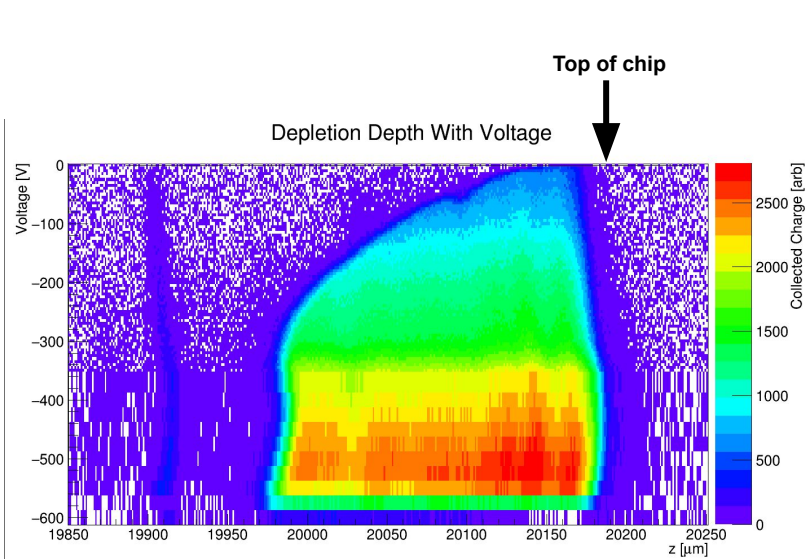
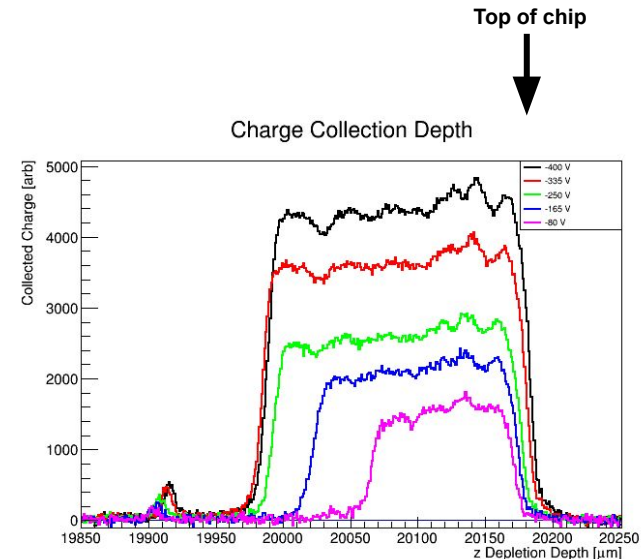
Depletion Depth Voltage Scan

- x and y values fixed
- z scanned (up/down) to measure depletion region growth
- Sensor biased between 0 to -600 V

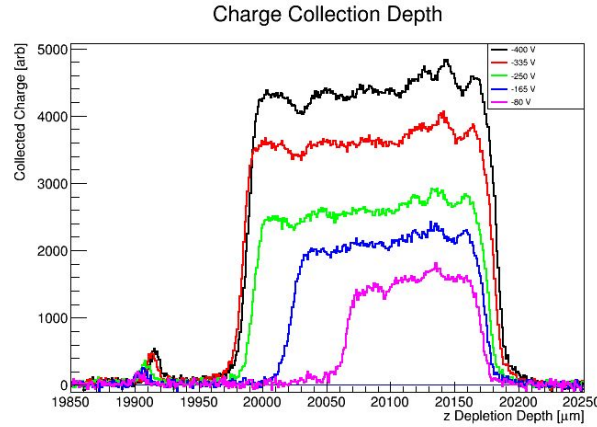
- FWHM of collected charge found for the region at each Voltage
- Substrate resistivity and doping concentration calculated from fit
- Unexpected depletion region stop
 - Bulk Damage?
 - Scratch on chip edge?
- Resistivity found

Resistivity (kΩ cm)
UKRI-MPW0 Nominal	1.9
UKRI-MPW0 Experimental	1.4 ± 0.2
RD50-MPW1 Experimental (Same Wafer)	1.3

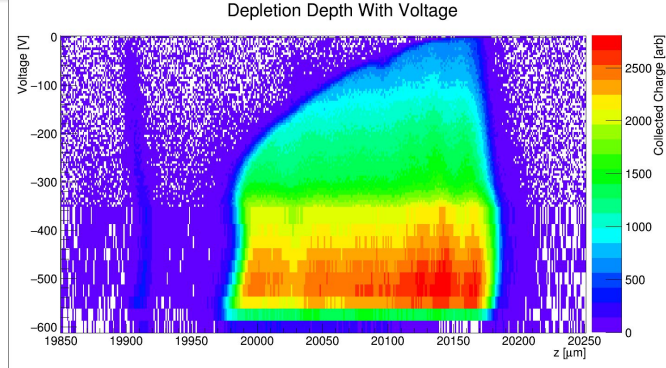
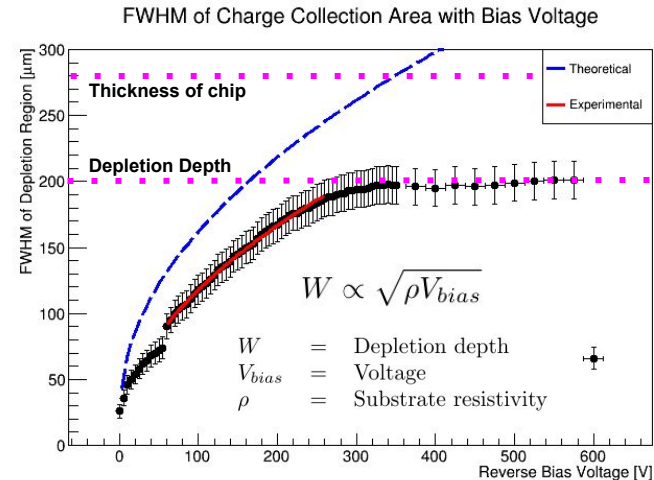
FWHM from all V values
